Purpose: To conduct annual wetland maintenance activities to protect and enhance Suisun Marsh managed wetlands.

Typical Cross Sections

Location: Suisun Marsh – near Suisun City, Solano County, State of California
At: Individually owned State and private properties

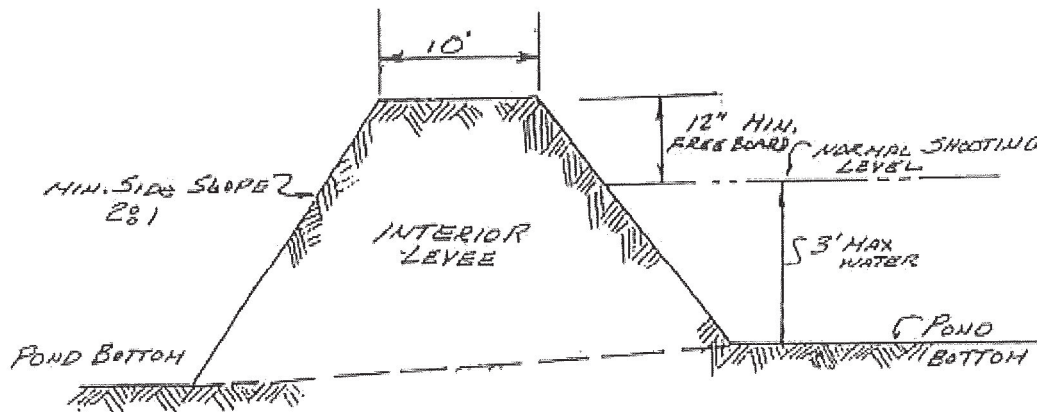
SECTION
INTERIOR LEVEE
NO SCALE

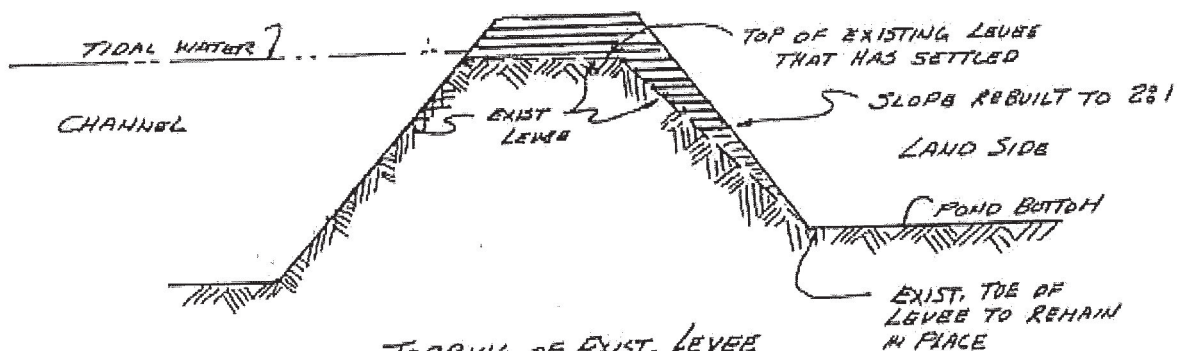
TOPPING OF EXIST. LEVEE
AND REBUILDING SIDE SLOPES
NO SCALE
WITH SETTLEMENT & EROSION

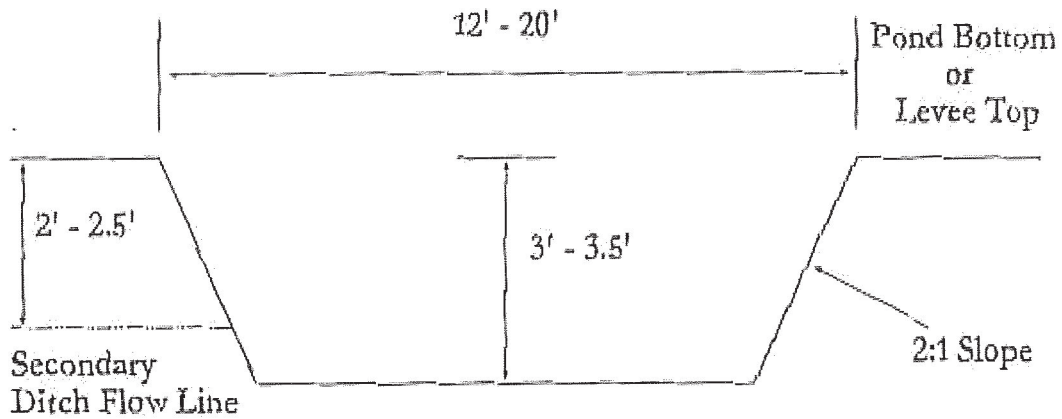
Cross Section of Primary Ditch

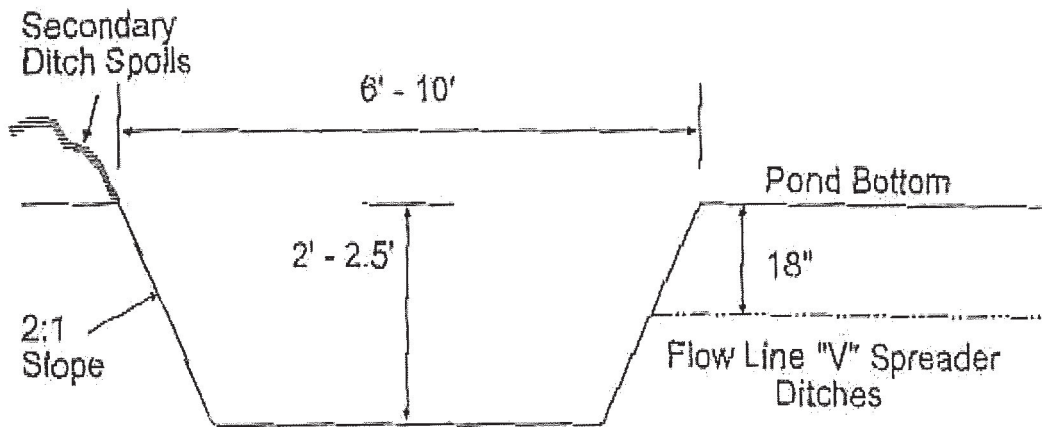
Cross Section of Secondary Ditch

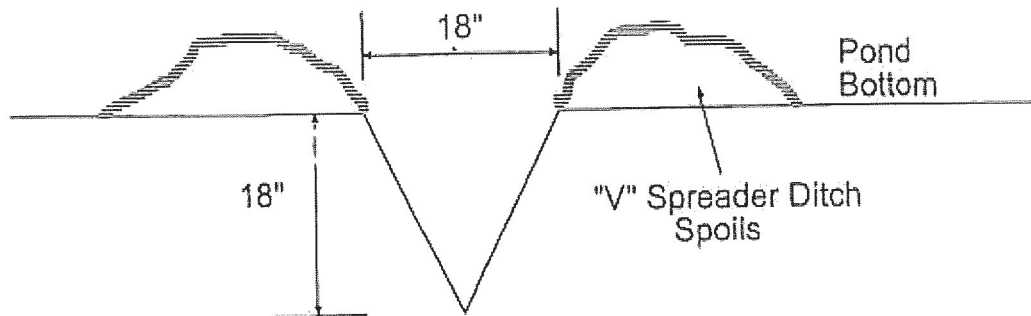
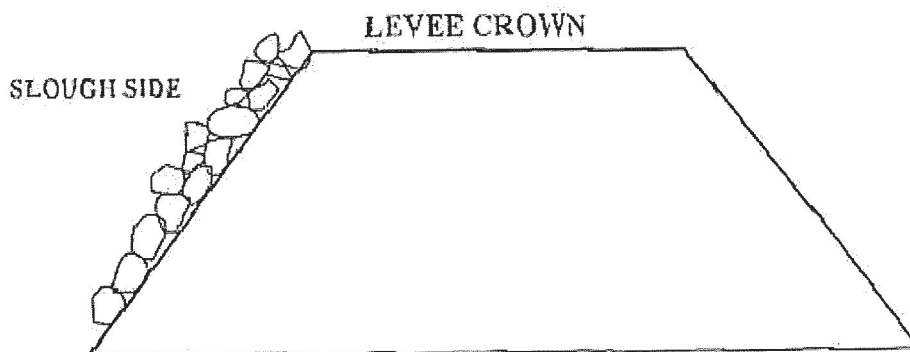
Typical Levee Section For the Replacement of Rip-Rap

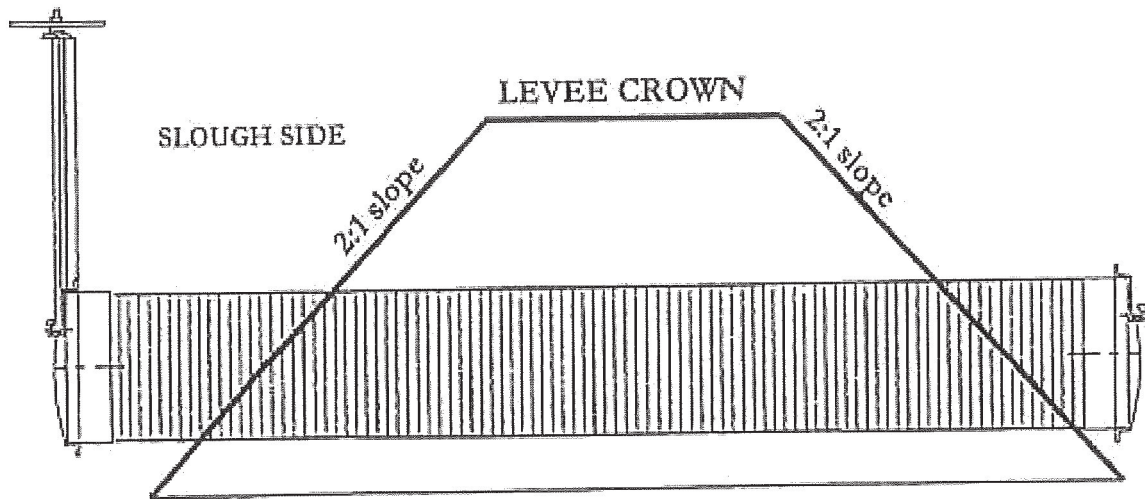
Typical Levee Section For a Flood Gate

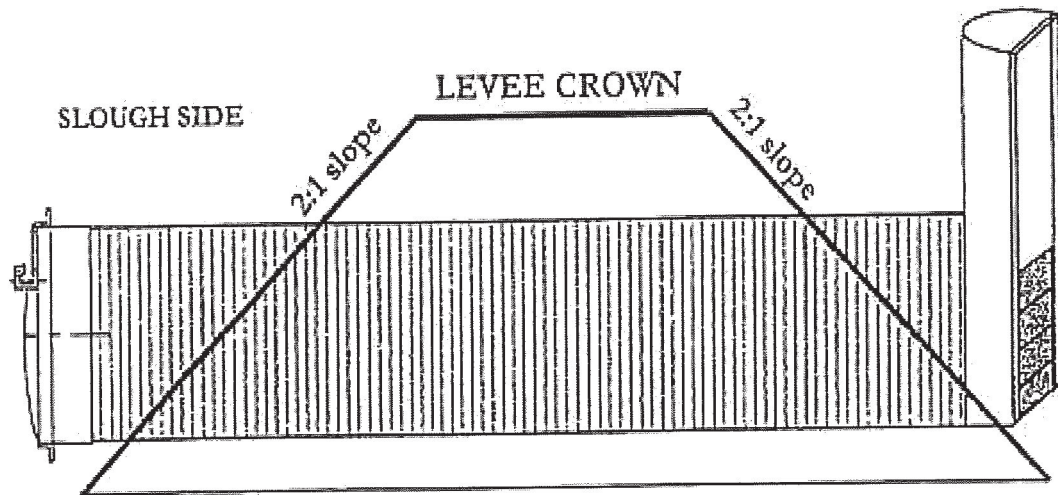
Typical Levee Section For a Drain Gate

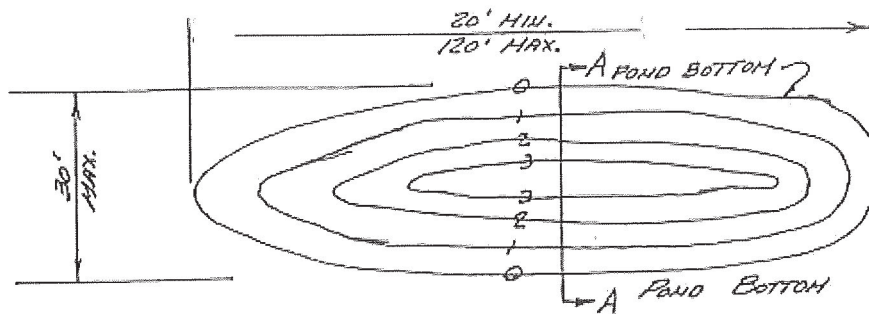
PLAN VIEW
NESTING ISLANDS
NO SCALE

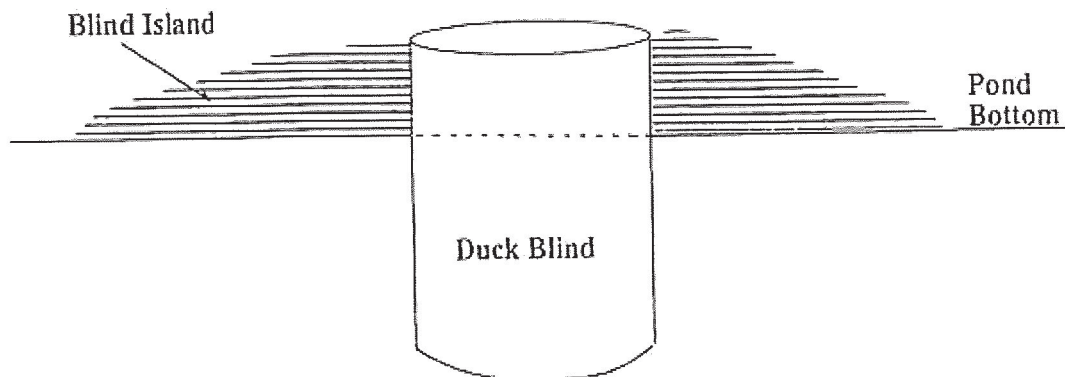
Typical Duck Blind and Blind Island Cross Section
