Lower Joice Island #424

Individual Ownership Adaptive Habitat Management Plan

(Revised: March 2021)

Suisun Resource Conservation District

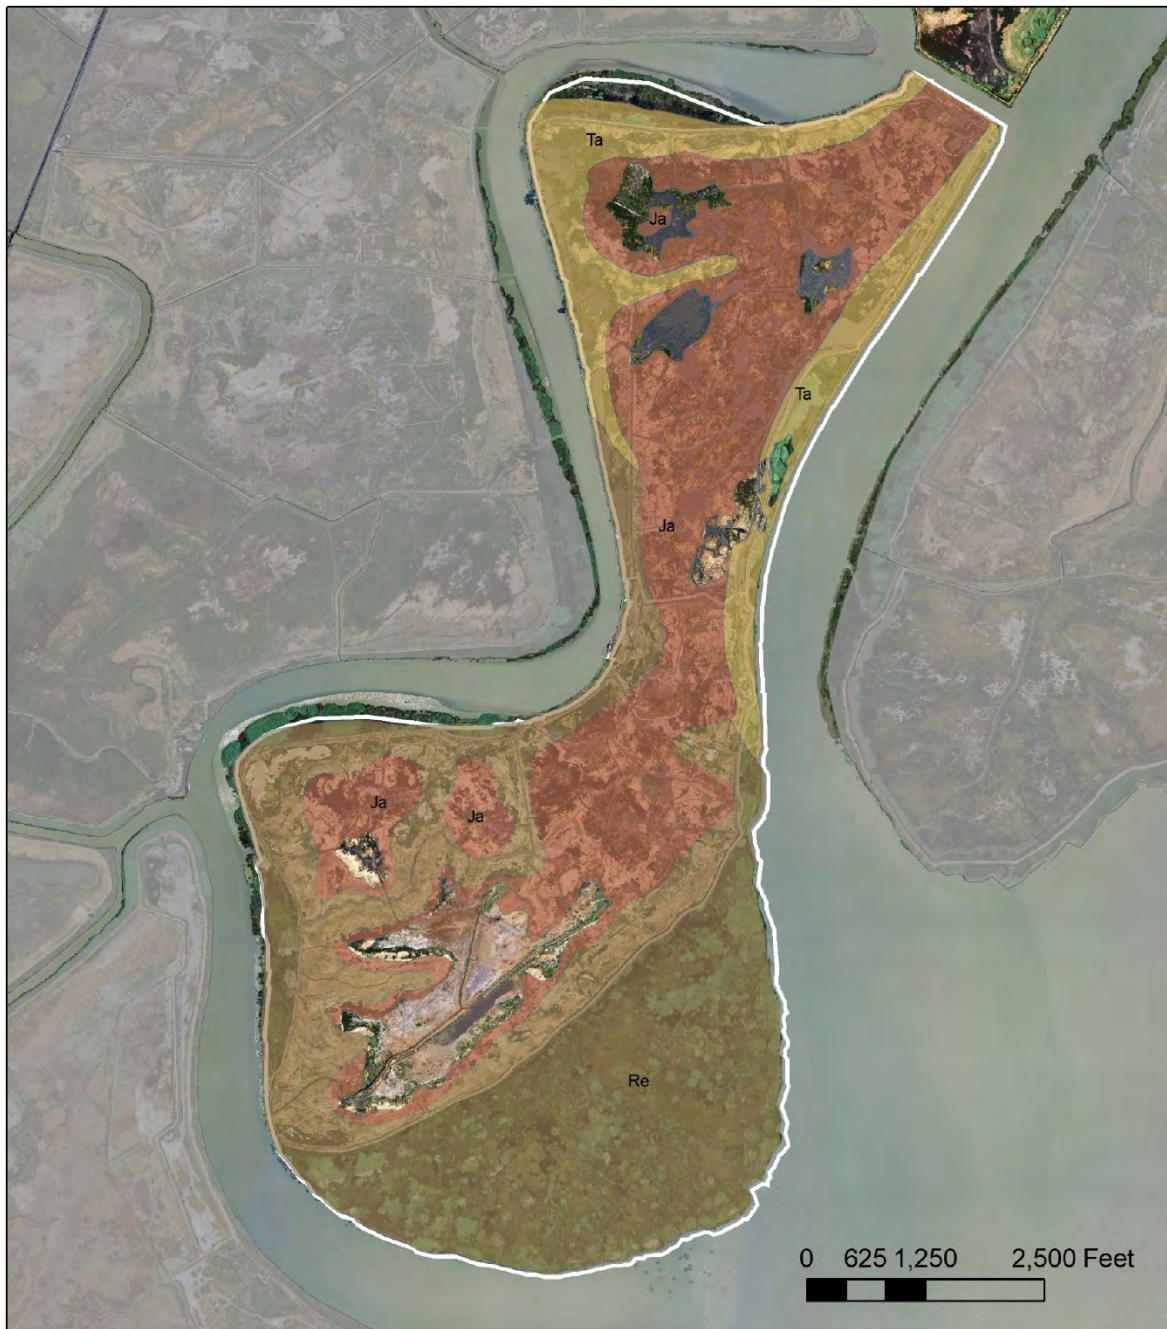
- Ja - Joice muck
- Re - Reyes silty clay
- Ta - Tamba mucky clay

Map 4. The primary soils on Club #424 include Joice muck (33.3%), Reyes silty clay (43.1%), and Tamba mucky clay (11.6 %). Source: Natural Resources Conservation Service Web Soil Survey, Version 14, May 29, 2020.

In 1978, the Soil Conservation Service surveyed the soil and provided a detailed summary map with soil descriptions for the managed wetland properties in the Marsh. The intention of the survey was to be used as a guide for wetland managers on vegetation, irrigation, and management. A current soil map was obtained from the Web Soil Survey (WSS) website. The WSS is operated by the U.S. Department of Agriculture (USDA) Natural Resources Conservation Service (NRCS) and is updated and maintained as the single authoritative source of soil survey information. The primary soils on this property include Joice muck (33.3%), Reyes silty clay (43.1%), and Tamba mucky clay (11.6%) (**Map 4**). See **Appendix L** for more detailed information about Suisun Marsh soils.
