Lower Joice Island #424

Individual Ownership Adaptive Habitat Management Plan

(Revised: August 2021)

Suisun Resource Conservation District

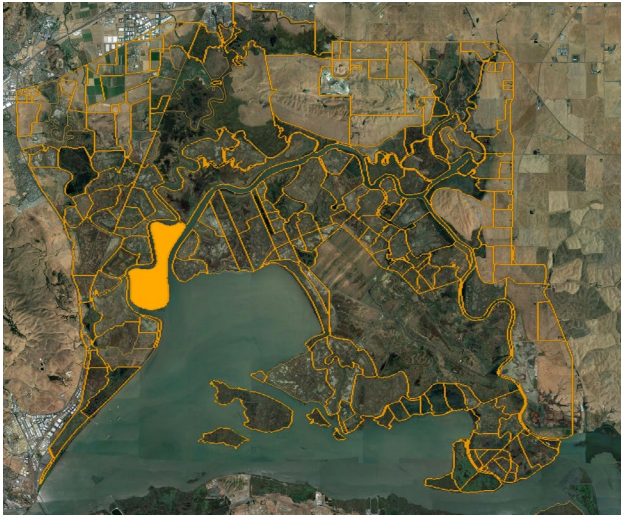
Figure 2. Property location in Google Earth.

Lower Joice Island (SRCD Ownership #424) is located on the southwest side of Suisun Marsh. Access to the property is off Goodyear Road, east to the end of Pierce lane across the railroad tracks and to the north approximately 0.5 miles. The property is accessed only by boat from Pierce Harbor. (**Figure 2**). The original management plan for Joice Island Gun Club (SRCD parcel #424) was certified by the San Francisco Bay Conservation & Development Commission on Nov. 15, 1984.

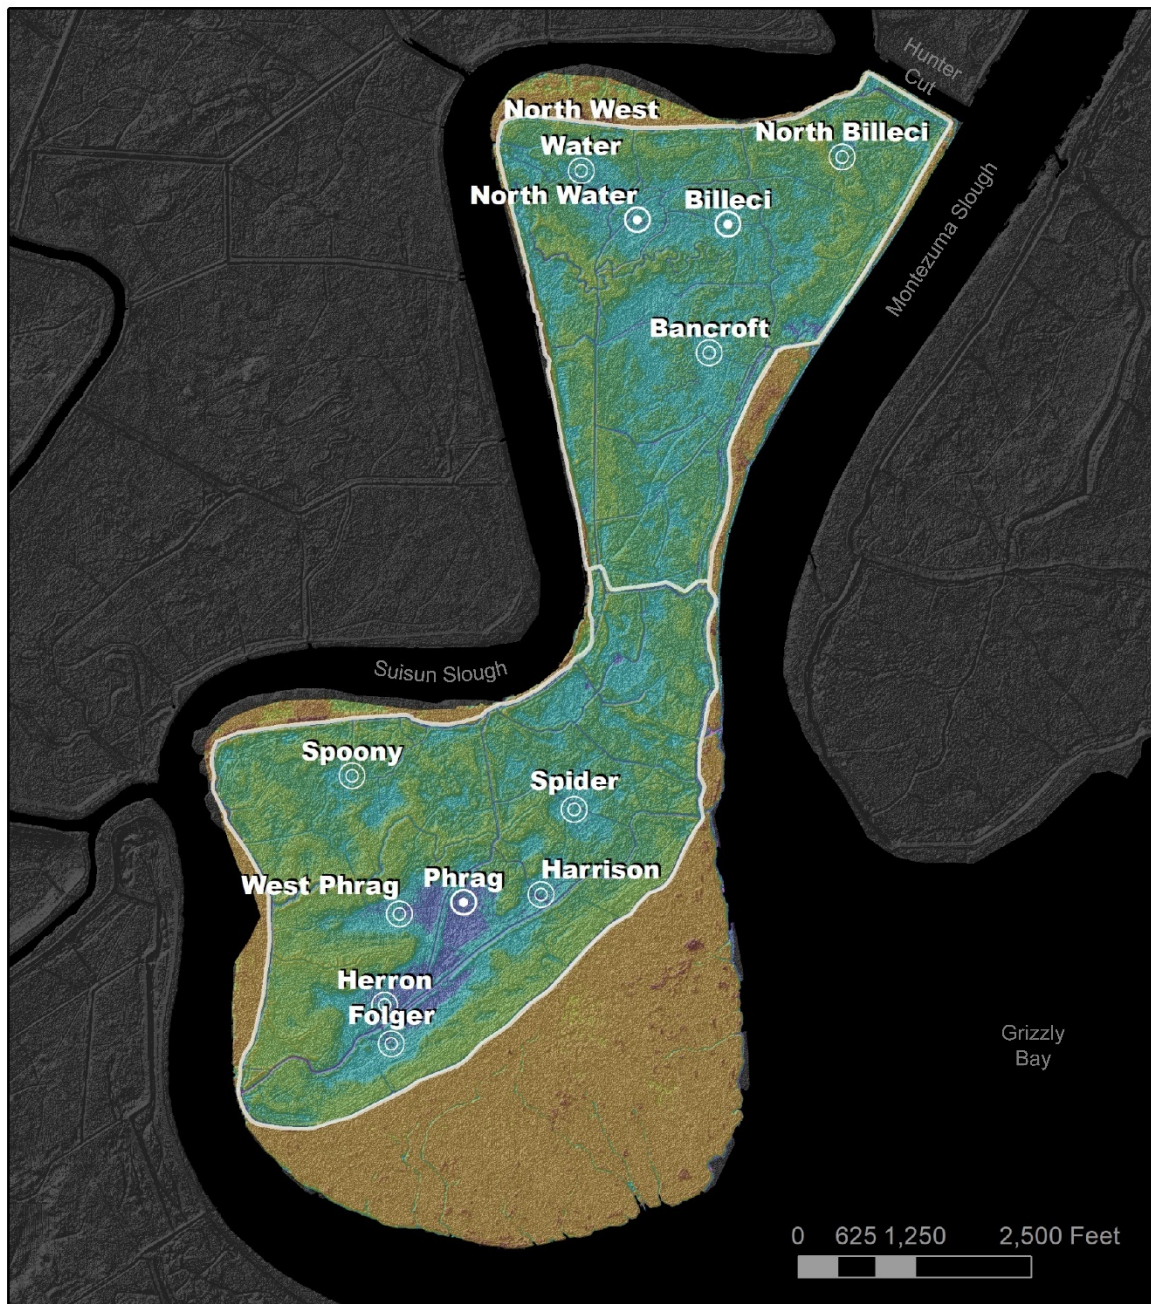
Average Pond Bottom Elevation: North = 3.23 feet (NAVD88), South = 3.44 feet (NAVD88)

Club Shoot Level Elevation: North = 4.34 feet (NAVD88), South = 3.98 feet (NAVD88)

Map 3. In 2018, the average pond bottom elevation for the north pond was 3.23 feet (NAVD88) and for the south pond was 3.44 feet (NAVD88) compared to an overall average bare earth elevation of 2.41 feet (NAVD88) for the Marsh primary management area. Sources: Buffington et al. 2019 and Chappell et al. 2018.

In 2018, an airborne Light Detection And Ranging (LiDAR) survey was completed to collect elevation data across the Marsh. However, dense vegetation may obscure the ability to measure the bare earth elevation. In this LiDAR-derived elevation map, we corrected for vegetation height to obtain the wetland pond bottom elevation (Buffington et al. 2016). We used multispectral airborne imagery and field surveys to improve elevation accuracy from 40% to 75% in a high-resolution image (1-m pixels). We have provided a map from the LiDAR data for Club #424 along with associated target staff gauge elevation data collected as part of the Managed Wetland Assessment (MWA: Chappell et al. 2018) project during that same year (**Map 3**).

Elevations were measured using the North American Vertical Datum of 1988 (NAVD88). A vertical datum is used as a reference system to measure and relate elevations to the earth's surface and NAVD88 is the official vertical datum for the contiguous United States (U.S.). In 2018, the average pond bottom elevation measured for Unit 1 was 3.23 feet (NAVD88) and the average pond bottom elevation measured for Unit 2 was 3.44 feet (NAVD88) compared to an overall average bare earth elevation of 2.41 feet (NAVD88) for the Suisun Marsh primary management area. The complete LiDAR coverage is available at the U.S. Geological Survey (USGS) Science Base website (Buffington et al. 2019).

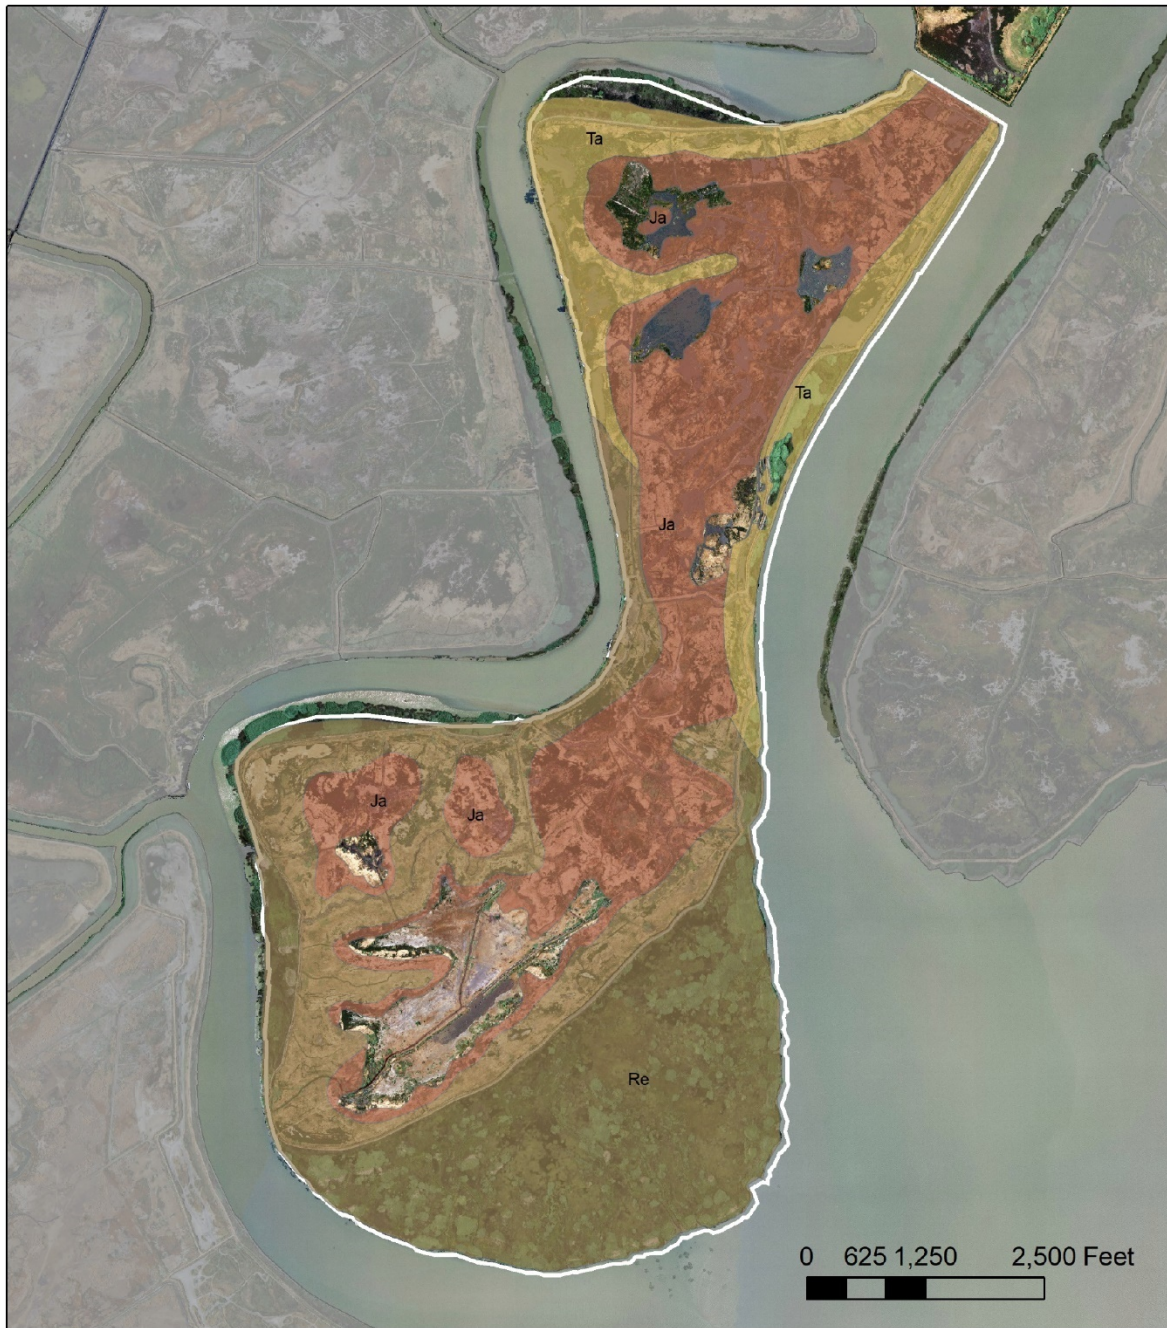
- Ja - Joice muck
- Re - Reyes silty clay
- Ta - Tamba mucky clay

Map 4. The primary soils on Club #424 include Joice muck (33.3%), Reyes silty clay (43.1%), and Tamba mucky clay (11.6 %). Source: Natural Resources Conservation Service Web Soil Survey, Version 14, May 29, 2020.

In 1978, the Soil Conservation Service surveyed the soil and provided a detailed summary map with soil descriptions for the managed wetland properties in the Marsh. The intention of the survey was to be used as a guide for wetland managers on vegetation, irrigation, and management. A current soil map was obtained from the Web Soil Survey (WSS) website. The WSS is operated by the U.S. Department of Agriculture (USDA) Natural Resources Conservation Service (NRCS) and is updated and maintained as the single authoritative source of soil survey information. The primary soils on this property include Joice muck (33.3%), Reyes silty clay (43.1%), and Tamba mucky clay (11.6%) (**Map 4**). See **Appendix L** for more detailed information about Suisun Marsh soils.

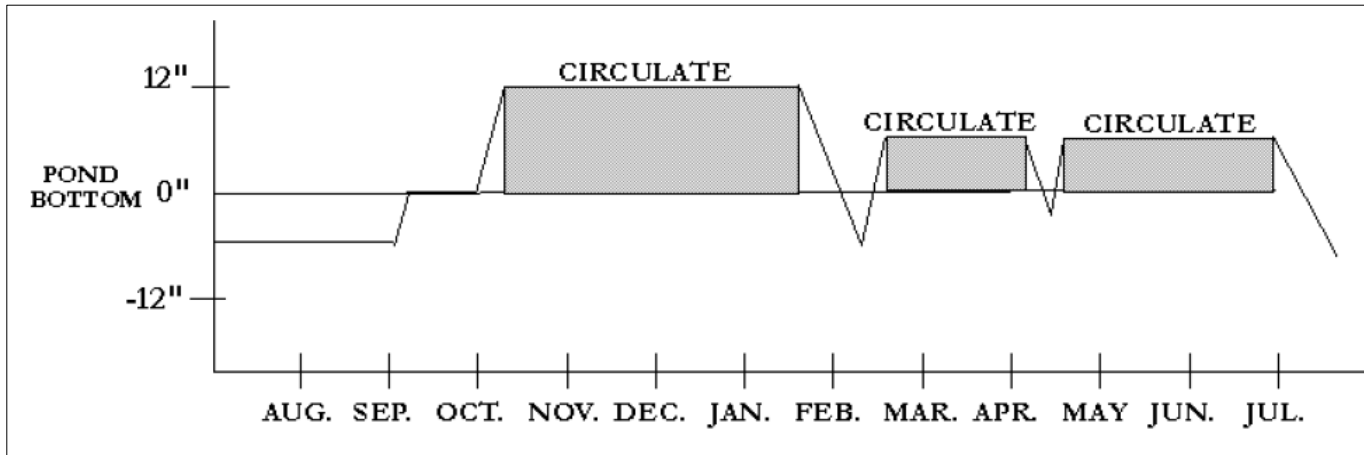
Figure 7. No Intake Restrictions / Normal Flood Date / Long Hydroperiod (Barthman-Thompson et al. 2007).

Water management is the primary means for habitat managers to manipulate managed wetland vegetation communities in the Marsh. SRCD developed eleven water management schedule guidelines to assist the wetland property owners and managers. The schedules are intended as guidelines because site specific factors will influence actual management decisions that will be made to reach the objectives for the property, and because management schedules will change for different regions in the Marsh and for different water years (**Appendix O**). Site-specific regulatory and physical conditions will influence actual management practices on individual properties. Below are two examples of these typical water management schedules (**Figures 7 & 8**, see **Appendix O** for other schedules).

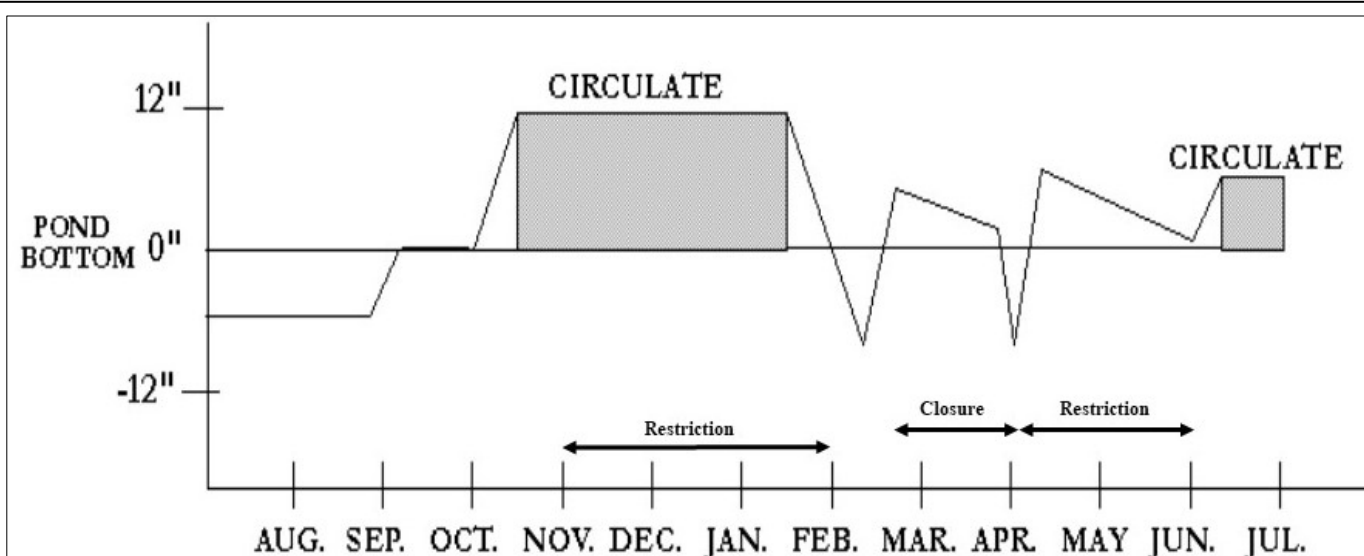
Figure 8. All potential intake restrictions/Long Hydroperiod (Barthman-Thompson et al. 2007).
